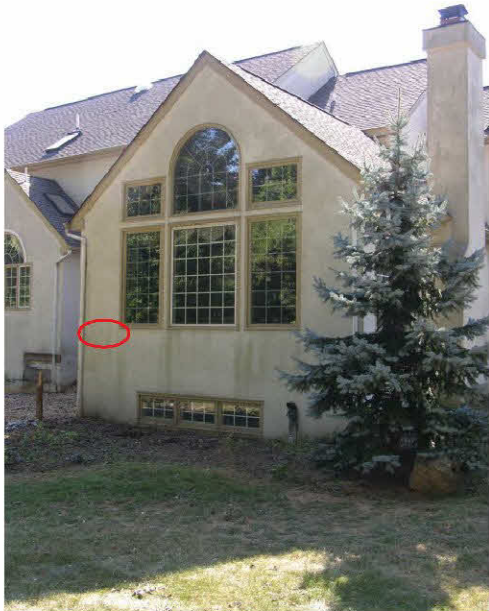
REAR ELEVATION MULTIPLE WINDOW INSTALLATION.

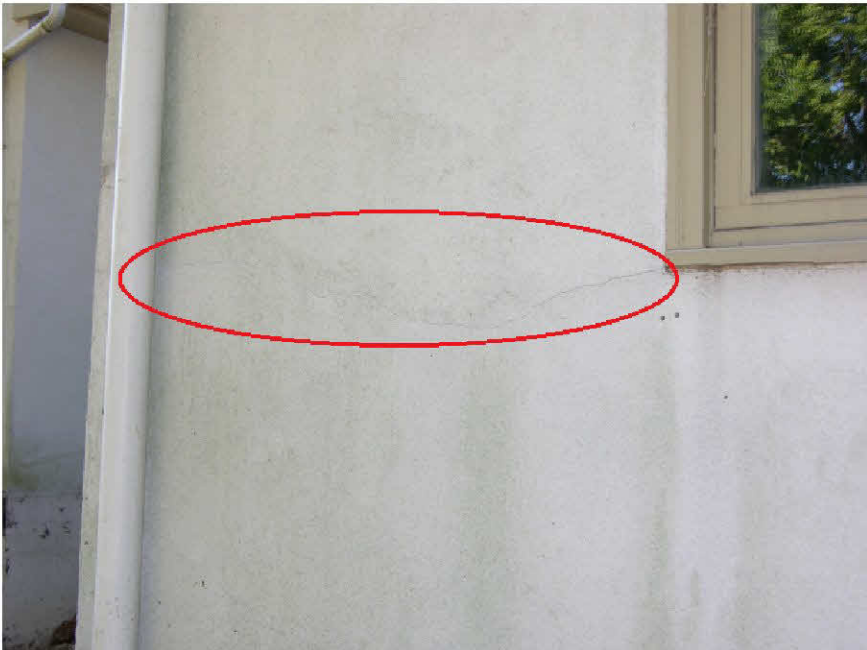
CLOSE-UP OF CRACKING PATTERN FROM WINDOWS TO EDGE OF STRUCTURE.
